Repairing a tear, gouge or rip in an industrial tire – NOT a Puncture

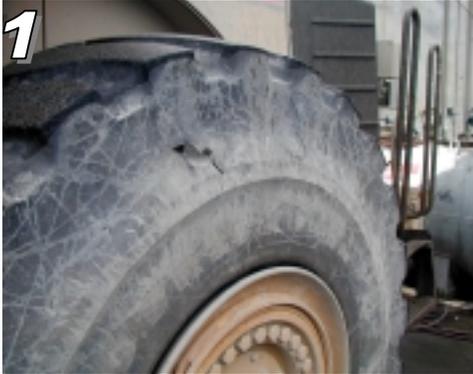
1 Deep gouges to the side of a large off road tire are often an OSA or MSHA violation.

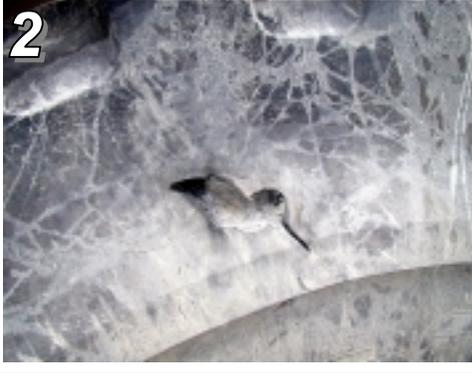
2 The steel radials are exposed to moisture which causes them to corrode, dramatically reducing the working life of the tire
